BUILDING-STRUCTURE INVENTORY FORM

1. BUILDING NAME(S): Butts - Carpenter - Lewis House
2. COUNTY: Monroe TOWN/CITY: Greece VILLAGE: ---
3. STREET LOCATION: 176 Kuhn Road (N.E. corner of Flynn Rd.)
4. OWNERSHIP: a. public ☐ b. private ☒
5. PRESENT OWNER: Stephany S. Barker ADDRESS: (same) Rochester, NY 14612
6. USE: Original: farm/residence Present: residence
7. ACCESSIBILITY TO PUBLIC: Exterior visible from public road: Yes ☒ No ☐
Interior accessible: Explain private residence

Town of Greece Historic Sites Survey
Monroe County, New York
176 Kuhn Road
page 6

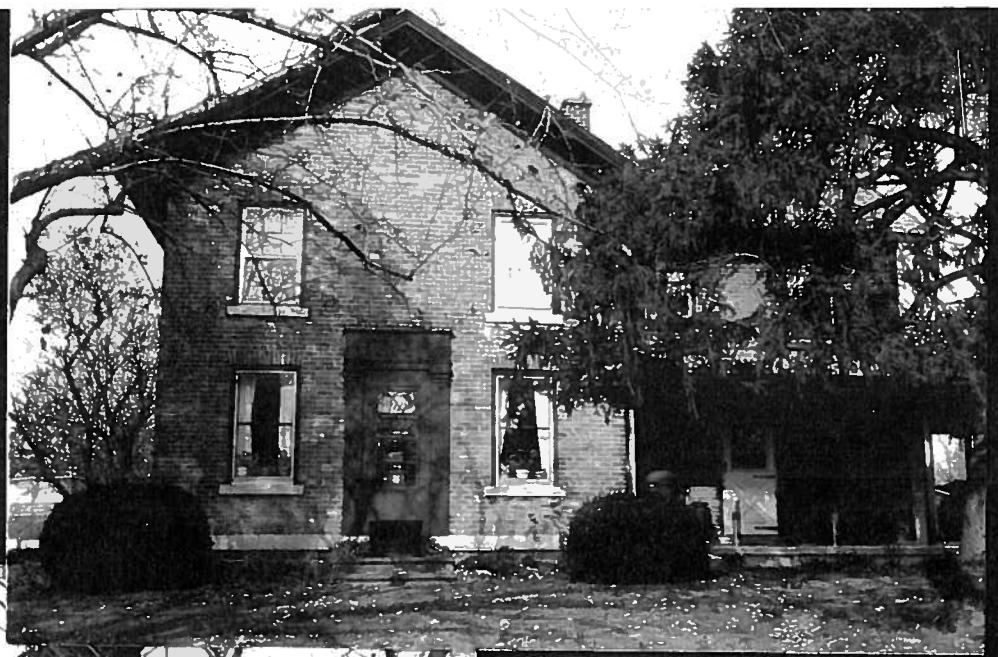
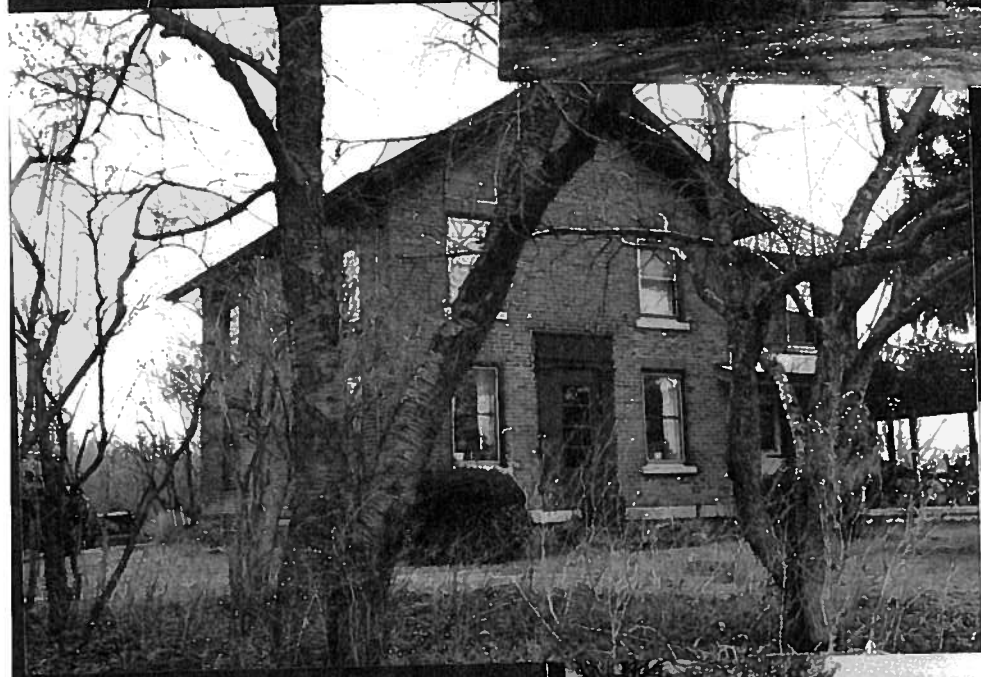
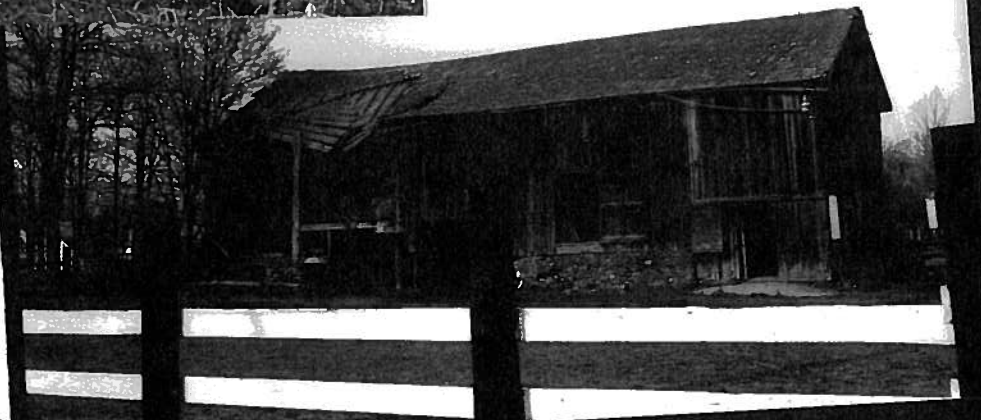
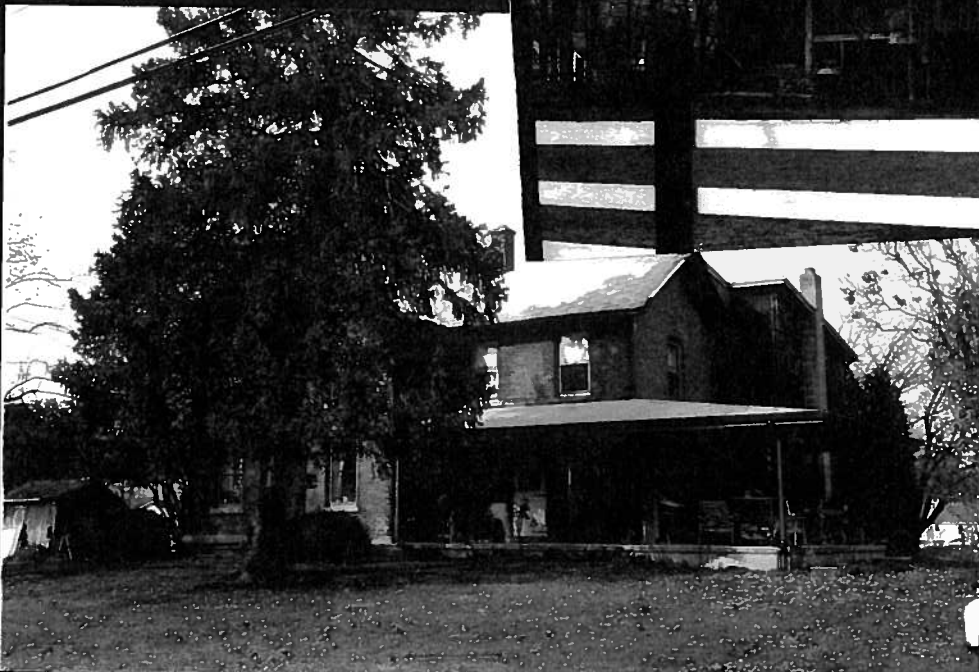
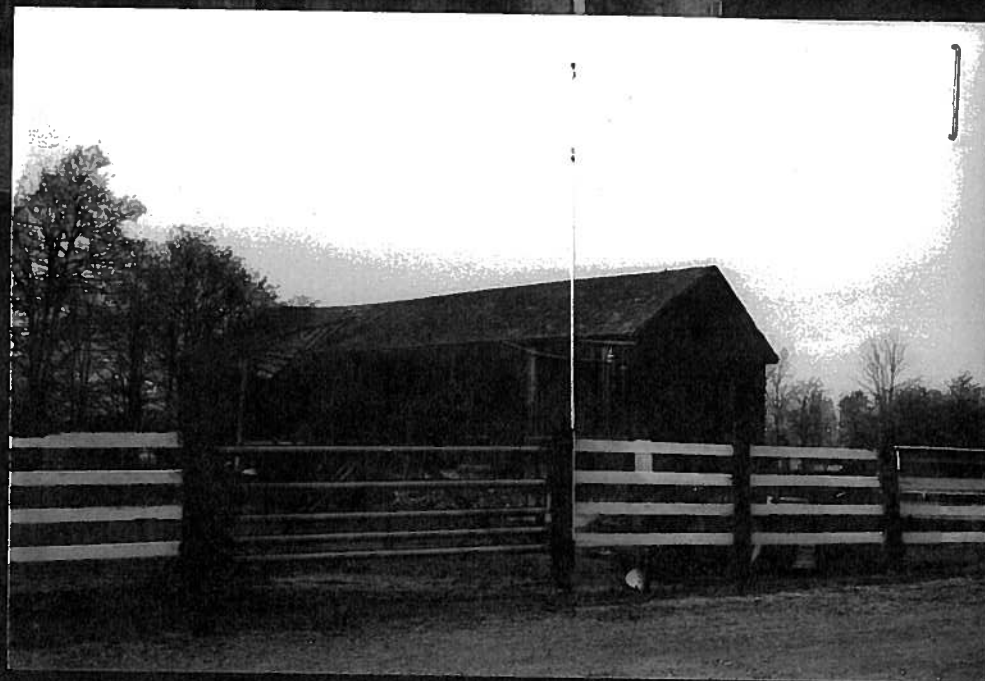
12. PHOTO:

18. A two-story, gable-front-and-side-wing, brick farmhouse (c. 1852) with a two-story, shed-roofed contemporary north wing. The front-gabled block is three-bays wide by three-bays deep. The house stands on a fieldstone foundation. Exterior walls are brick (load bearing). Fenestration is regular and symmetrical with 1/1, double-hung windows. The window have brick lintels and stone sills. There is also a stone watertable (stone detailing appears to be limestone). The broadly-pitched roof has a wide overhang. A brick chimney tops the ridgeline of the side wing of the house.

In addition to the historic farmhouse, the property includes two contributing agricultural outbuildings: a small, gable-roofed shed to the west of the house (next to the driveway). Located farther west, near Flynn Rd., is a large, gable-roofed frame barn. This barn is of heavy post-and-beam construction (partially visible on the south facade, where the siding has been removed). The walls of the barn are of vertical wood siding. The foundation is of fieldstone. The upper part of the barn was once used for storage (hay, etc.) and the lower part currently houses several horses. Several sliding wood doors are visible on the south facade. The west end of the barn facade is missing most of its exterior siding and the wood-shingled roof has partially collapsed over this area.

A one-story, shed-roofed brick addition (date unknown) is attached to the north elevation of the barn. This addition is also in deteriorated condition and part of the brick wall has collapsed.

Although the house has a series of c. 1970s-'80s changes and additions, it still retains the basic form, massing, and some of the vernacular detailing of a mid-19th century farmhouse. A more sympathetically-designed north wing and wrap-around front porch would increase the architectural significance of this house.
